## RESEARCH AND INVESTIGATION INTO THE PERFORMANCE OF RESIDENTIAL BOUNDARY FENCING IN BUSHFIRES

A recent testing project involving the Co-operative Research Centre for Bushfire (Bushfire CRC) and the CSIRO has revealed that different types of fencing can play an important part in defending homes against the threat of bushfire.

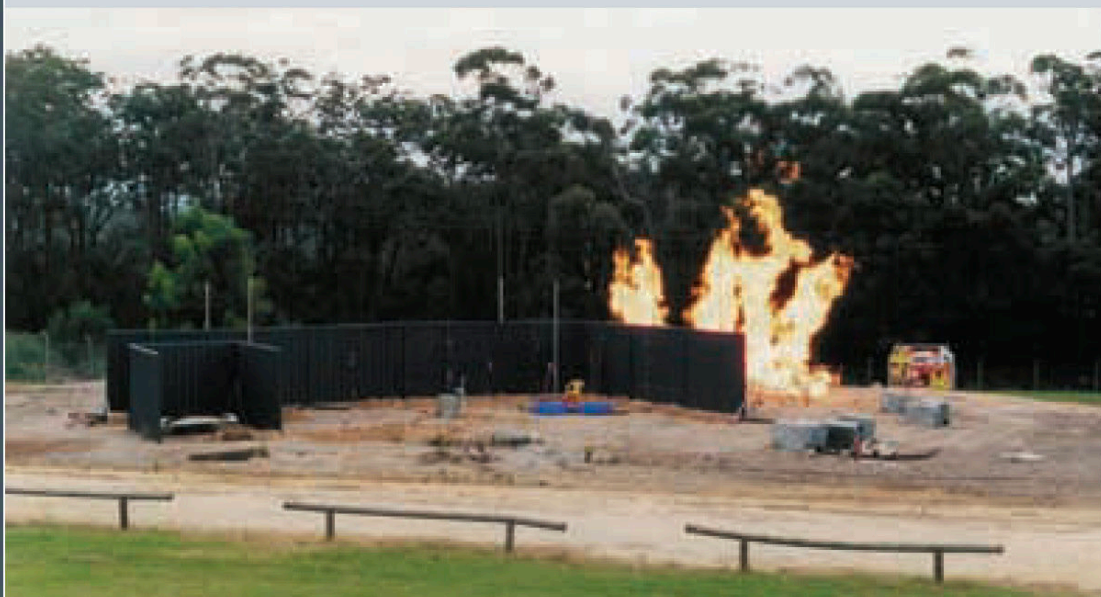
The research project was conducted in the NSW Rural Fire Service Experimental Testing Site at Mogo on the south coast of NSW, at what is believed to be the only bushfire simulator of this type in the world.

NSW RURAL FIRE SERVICE EXPERIMENTAL TESTING SITE AT MOGO.

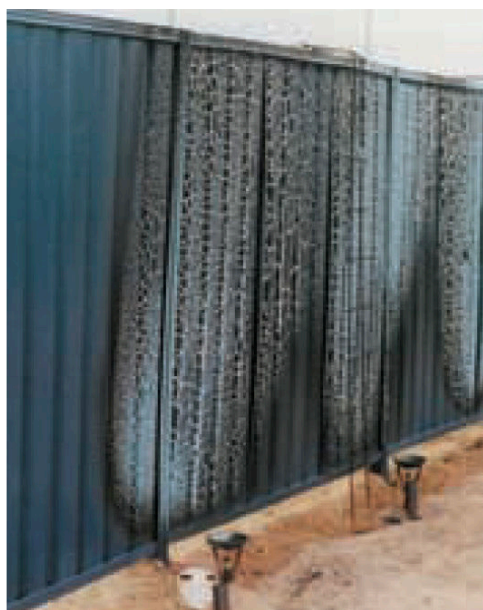
Hardwood timber fencing systems performed better than treated pine timber, supporting flame spread during the radiant heat and flame contact phases in exposure levels two and three. However, when faced with the 30-minute flame exposure test of level four, the hardwood timber fencing systems resulted in fence collapse within some minutes.
